Test Report Page 1 of 4 No.: XMHL2004001750OT Date: Apr. 28, 2020

: COMPACT LAMINATE Sample Description Style / Item No. : 8MM 10MM 12MM

Test Item: Tensile Strength Sample Description: Plastic part

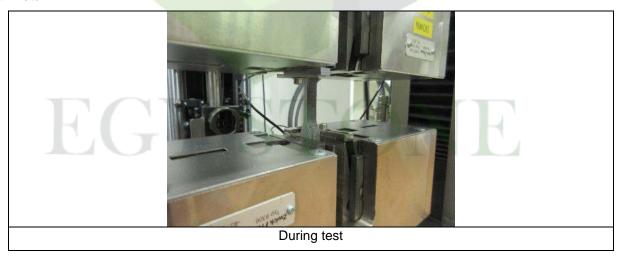
Test Photo:

Specimen: Type 1BA

Specimen thickness: 9.80 mm Testing speed: 5 mm/min

Initial distance between grips: 50 mm

Test Item	Test Result
Tensile Strength	89.6MPa
